Carey, J.M. and Petley, D.N. (2014) 'Progressive shear-surface development in cohesive materials; implications for landslide behaviour.', *Engineering geology*, 177 . pp. 54-65.

Title: Progressive shear-surface development in cohesive materials; implications for landslide behaviour

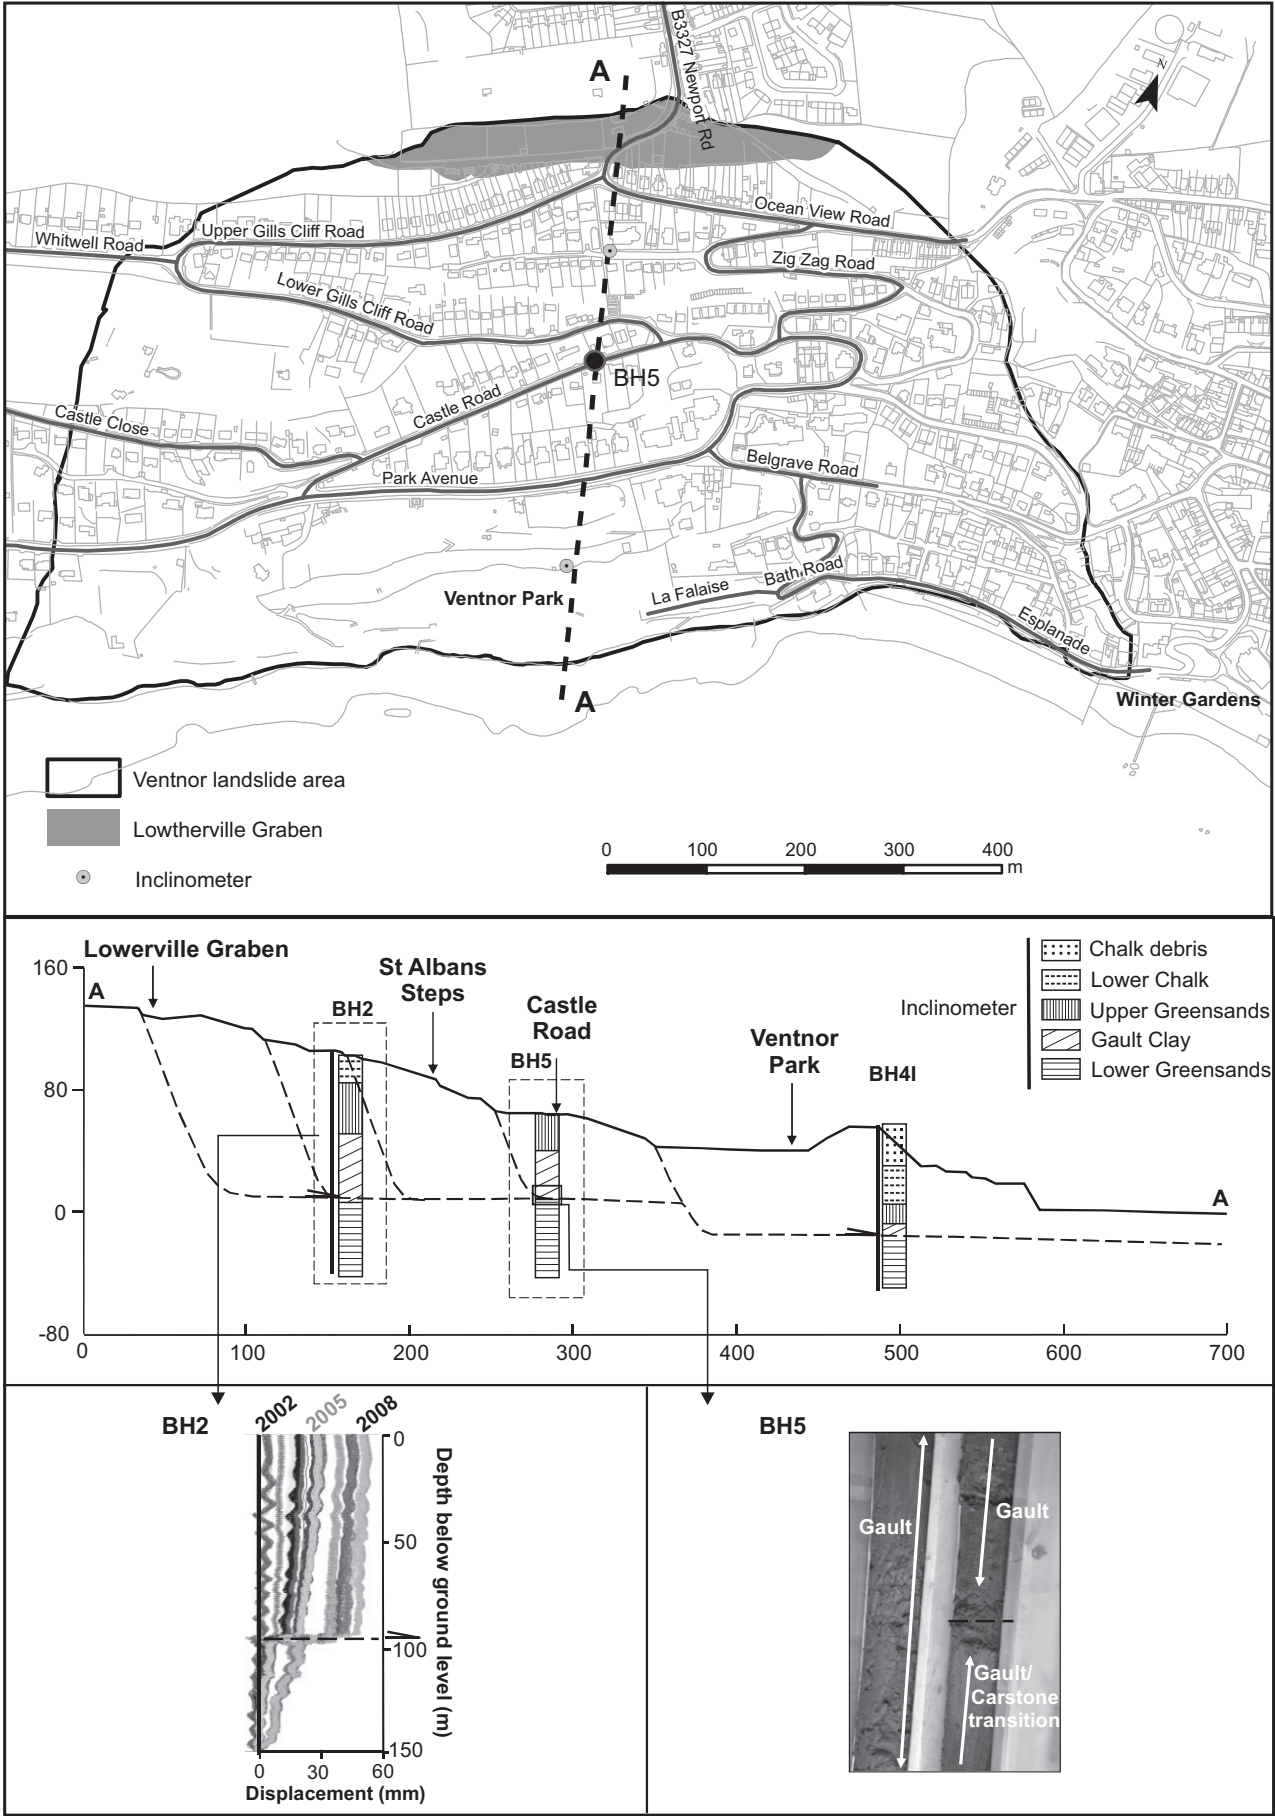
Figure 2

**Figure 2.** Schematic interpretation of the Ventnor landslide complex: (a) Map of the extent of the landslide complex, including the section line. Note the intensely urbanised nature of the landslide. (b) Schematic cross-section through the landslide, showing the multiple landslide blocks and the low angled shear surface; (c) inclinometer data showing the clear deformation at the sliding surface, located in this case at about 95 m below the ground level.

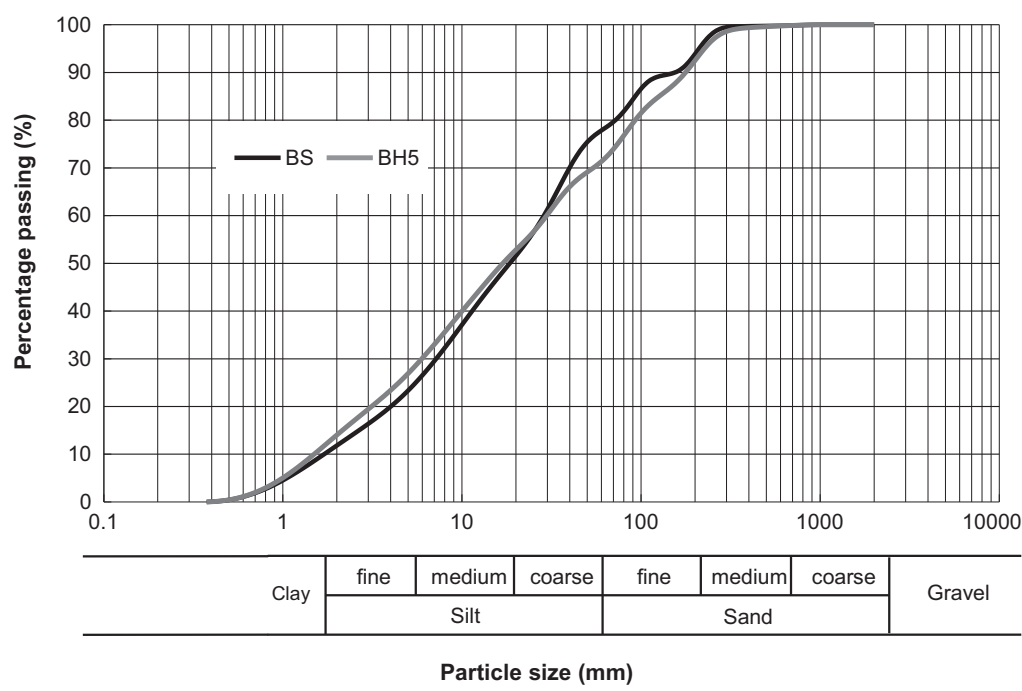
Figure 3

**Figure 3.** The particle size distribution of the Gault Clay samples from Block Sample (BS) and Borehole 5 (BH5)

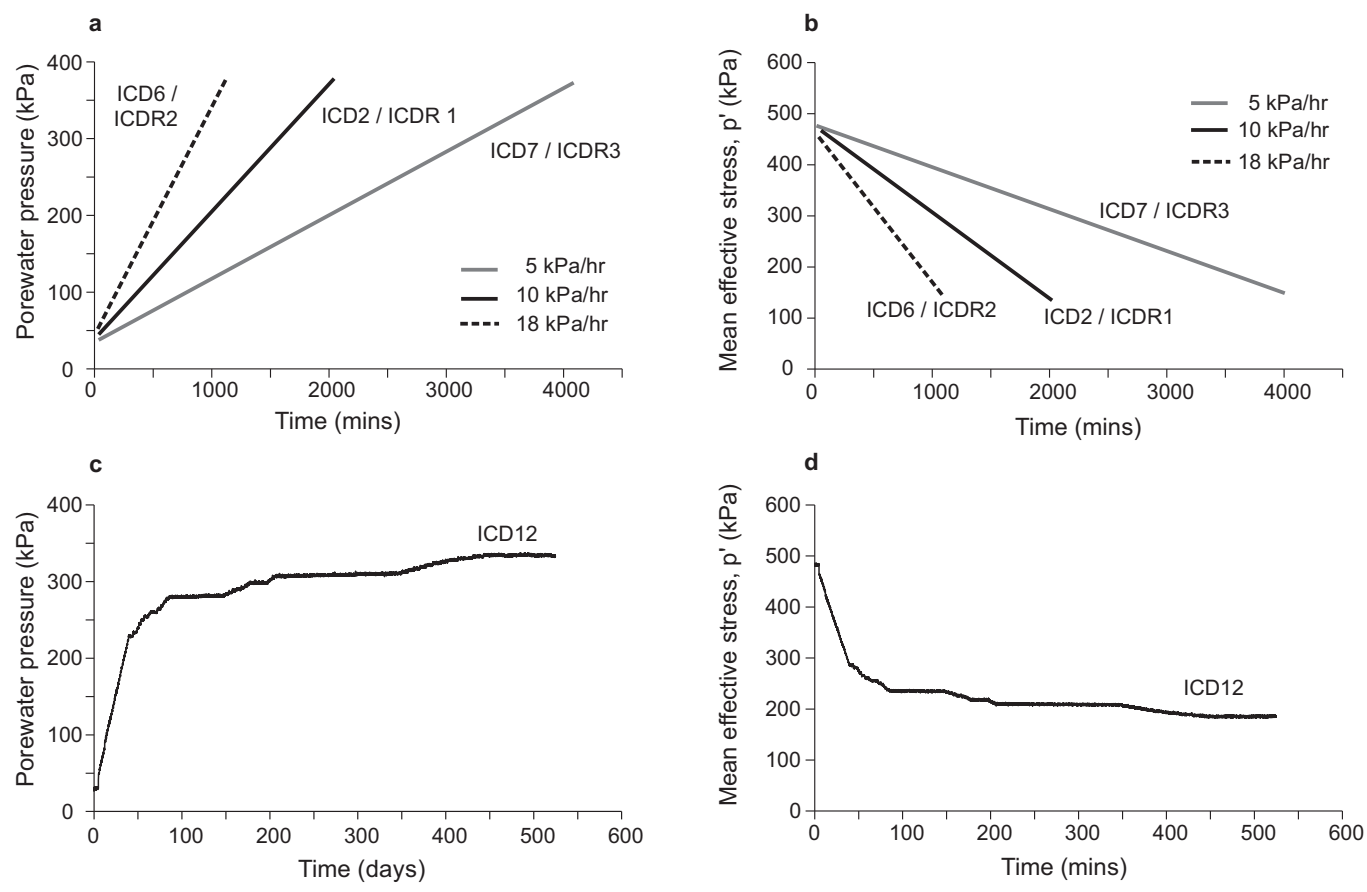
Figure 4

An initial set of standard soil classification tests were undertaken on the Gault Clay to establish the physical properties of the landslide materials at the basal shear zone (Table 1). Particle-size analyses (Fig. 4) indicate some variability across the Gault Clay samples. Samples from BH5 comprised of 14.1% clay, with silt contents of 39.3% and sand content of 46.6%. Whilst similar silt contents can be observed in BS samples (39.3%), a lower clay content of 11.9% and a higher sand content of 47.7% were recorded. Plastic limits were similar in both samples, although liquid limits were significantly higher in BH5. Atterberg limits indicate that the Gault Clay samples comprise high plasticity clay in BH5 and low plasticity clay in BS (defined in

An additional long-duration creep test was undertaken (ICD12) which aimed to study the potential for a shear surface to develop at a constant stress state (i.e. to simulate true progressive failure). In this test, the sample was subjected to the standard initial confining pressure of 350 kPa and initial drained shear of 400 kPa, in common with tests ICD2, 6 and 7. During the PPR stage, porewater pressure was incrementally increased in small steps before being held constant to study sample strain development (Fig 4c). As the test progressed, PPR phases were shortened and the constant PPR phases lengthened to determine whether strain development to failure could occur at constant mean effective stress (Fig 4 d).

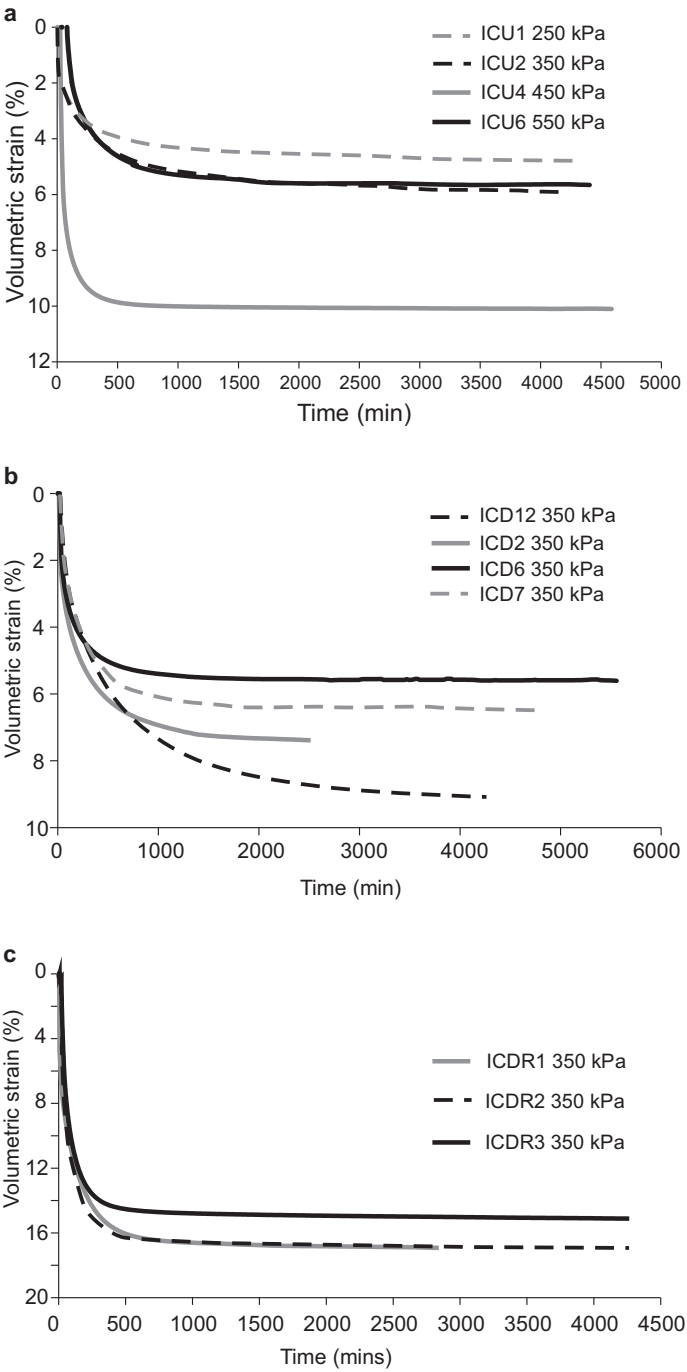
Figure 5

**Figure 5.** Change in volumetric strain through time during consolidation for: (a) the ICU tests; (b) the ICD intact tests; and (c) the ICD remoulded tests.

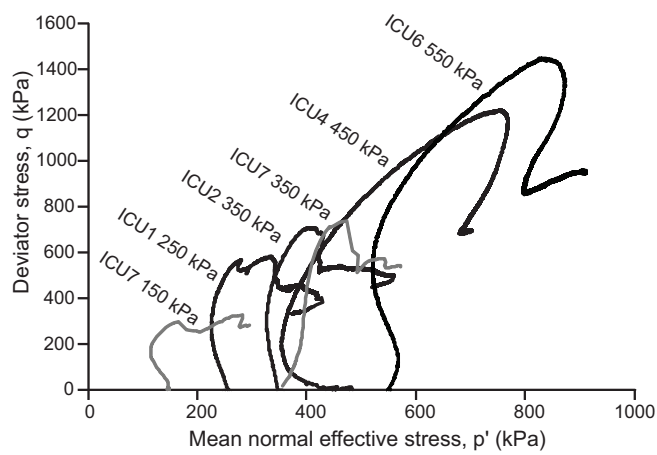
Figure 6

**Figure 6.** Undrained shear stress paths, including additional Gault Clay ICU stress paths from Carey (2002) to allow definition of the failure envelope.

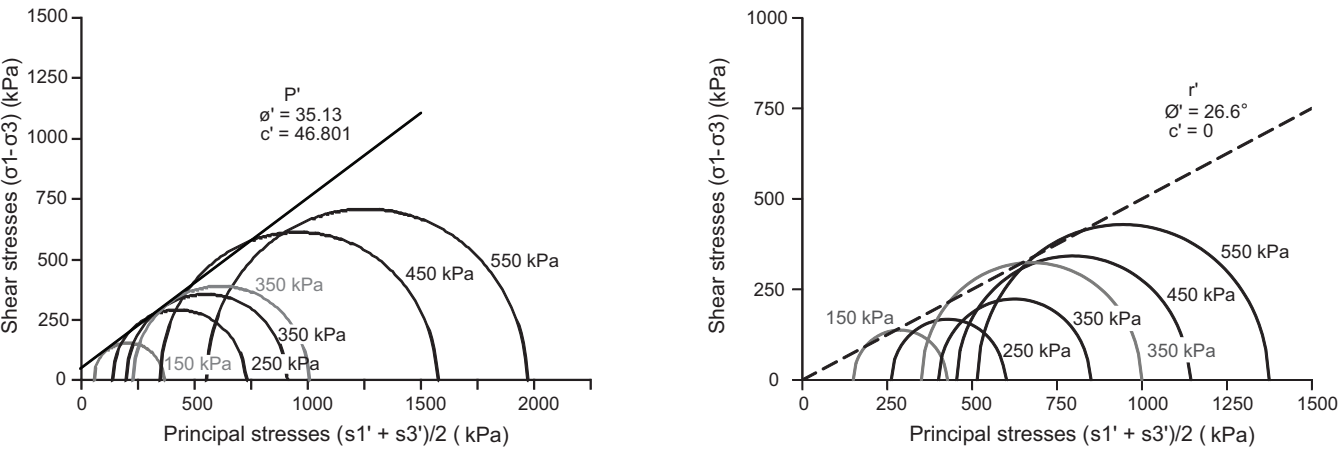
Figure 7

**Figure 7.** ICU Mohr Coulomb failure envelopes: (a) the peak strength envelope; and (b) the residual strength envelope.

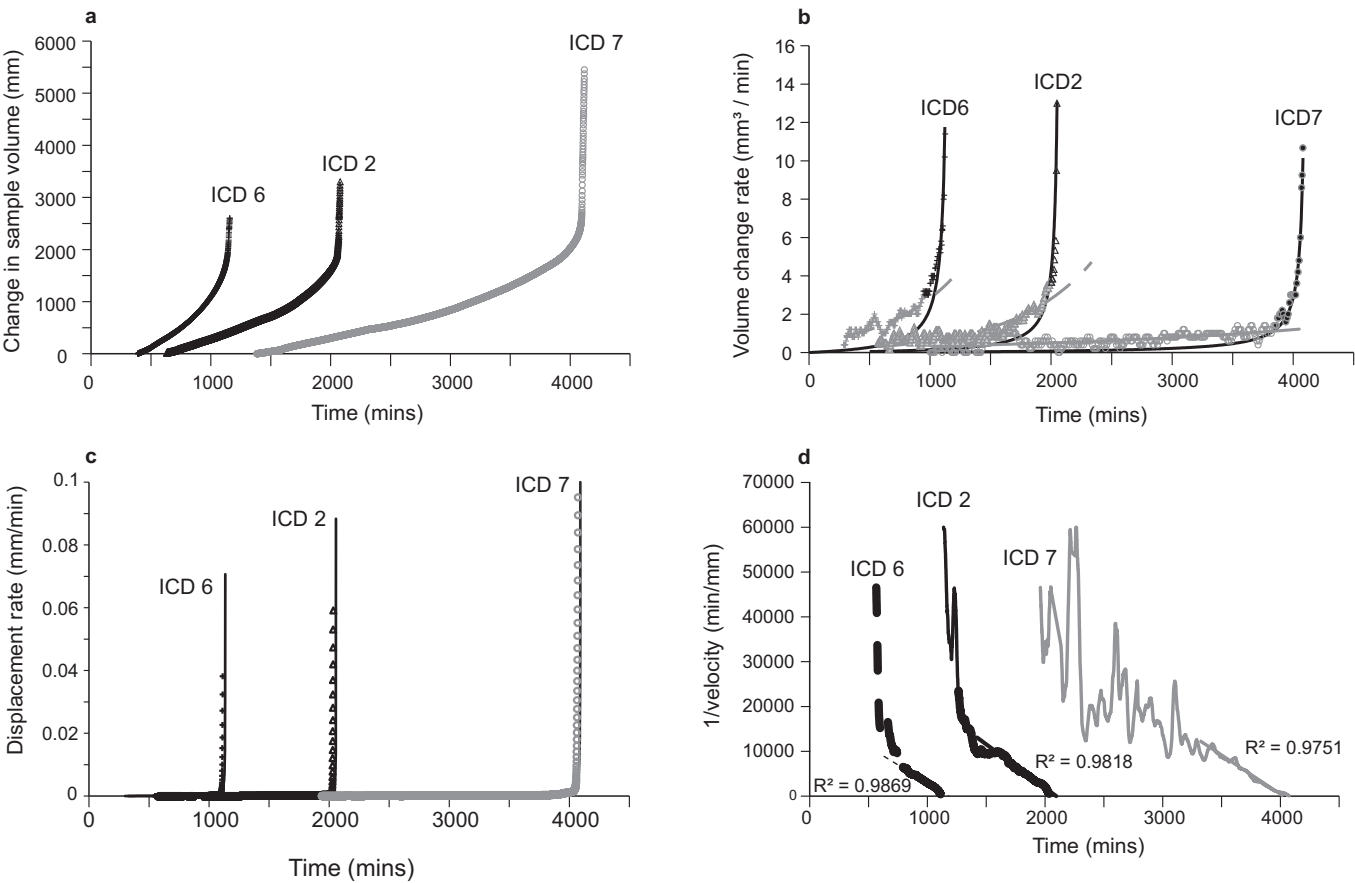
Figure 8

As the pore pressure increased further, the rate of dilation in the samples increased (Fig 8a). The rate of increase of volume change with time is best described by a hyperbolic trend in all three samples (Fig 8b), which matches the hyperbolic acceleration to failure observed in the displacement rate data (Fig 8c). This yields a linear trend in  $1/v - t$  space (Fig 8d), and is thus associated with strain localisation and the development of a shear surface (Kilburn and Petley 2003). Final failure in the samples was associated with the development of either a single shear surface, or in some cases of a conjugate pair of shear surfaces

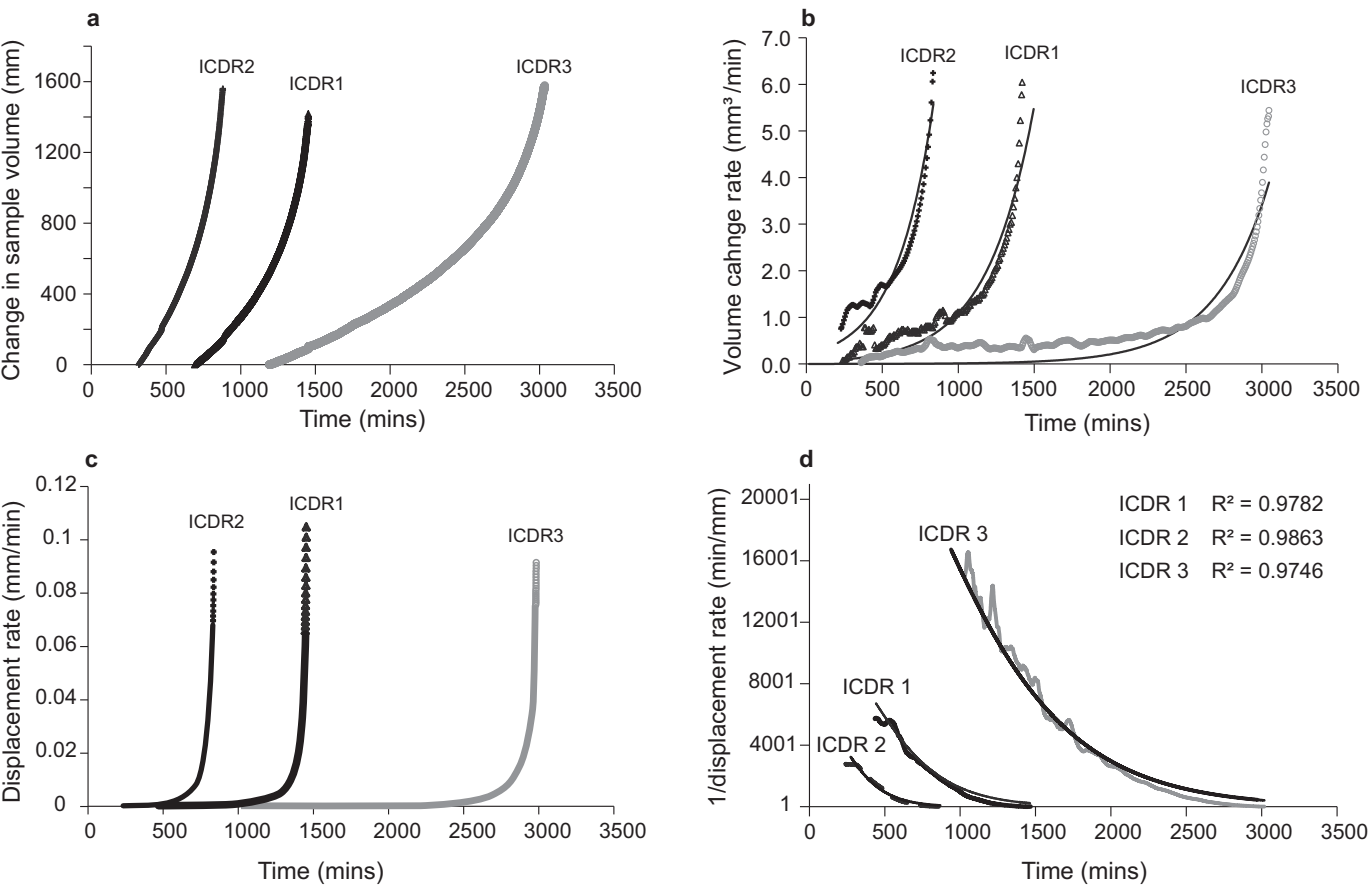
Figure 9

**Figure 9.** ICD linear PPR test results for the remoulded samples: (a) Change in sample volume v. time; (b) displacement rate against time; and (c) 1/ velocity vs. time.

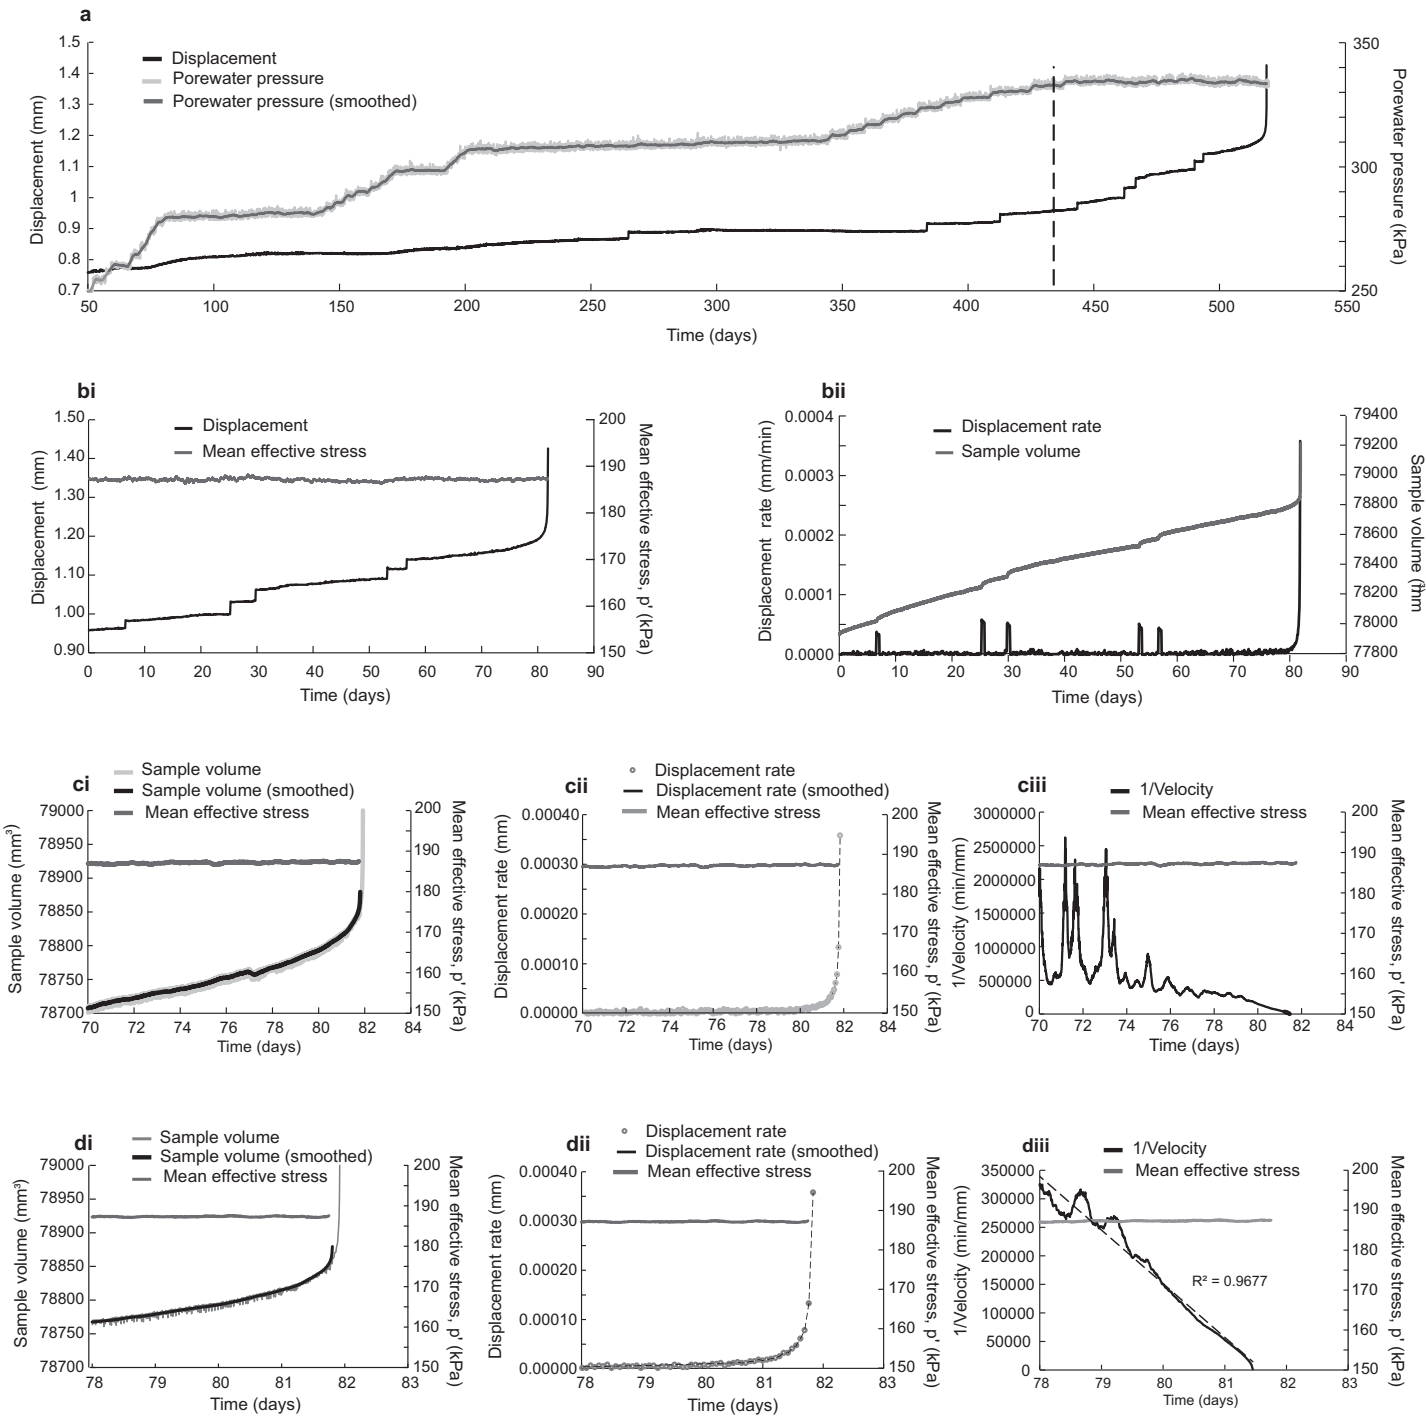
Figure 10

316 after the test had run for 524 days (Fig 10a). In the final phase of the test, the pore  
317 pressure was increased on day 444 thereafter it was kept constant for 81 days until  
318 failure occurred.

320 During the final 80 days the sample crept to failure at a constant effective stress (Fig  
321 10bi). As failure developed in the sample, strain developed constantly, but some  
322 notable stepped increases (Fig. 10bi) that were not associated with a change in  
323 effective stress state. The rate of occurrence of these five steps does not increase  
324 towards failure, suggesting that they are not precursors to the final failure event. Note  
325 however that they are associated with a change in sample volume; in each case there  
326 was a small amount of dilation (Fig. 10bii). It is unclear as to whether  
327 stepped pattern results of a stick-slip process or is a function of the test.

329 Final failure was initiated at Day 78 of this final stage of the experiment. The sample  
330 underwent a hyperbolic acceleration in rate of volume change with time and rate of  
331 displacement with time during the final few days (Fig 10 ci and ii). Final failure  
332 occurred at mean effective stress of approximately 187.5 kPa, which plots below the  
333 failure envelope derived from both the conventional and the PPR tests.

335 Analysis of the final 11 days of the test suggests that the sample dilated during  
336 deformation (Fig 10 ci), similar to that observed in the ICU PPR tests. The  
337 displacement rate was constant and acceleration to failure did not develop until day 78  
338 (Figure 10 cii and 10 ciii). Analysis of the final four days (day 78 to day 81) suggests  
339 rapid development of a shear surface during the final day of the test as the sample

dilated (Fig 10 di,) and displacement rate rapidly developed into a hyperbolic trend (Fig 10 dii). This is illustrated by the linearity in  $1/v, t$  space observed over the final four days (Fig 10 diii). The test indicates that whilst damage is occurring throughout the sample, the acceleration to failure resulting from strain localisation occurred very rapidly and very late in the deformation process.

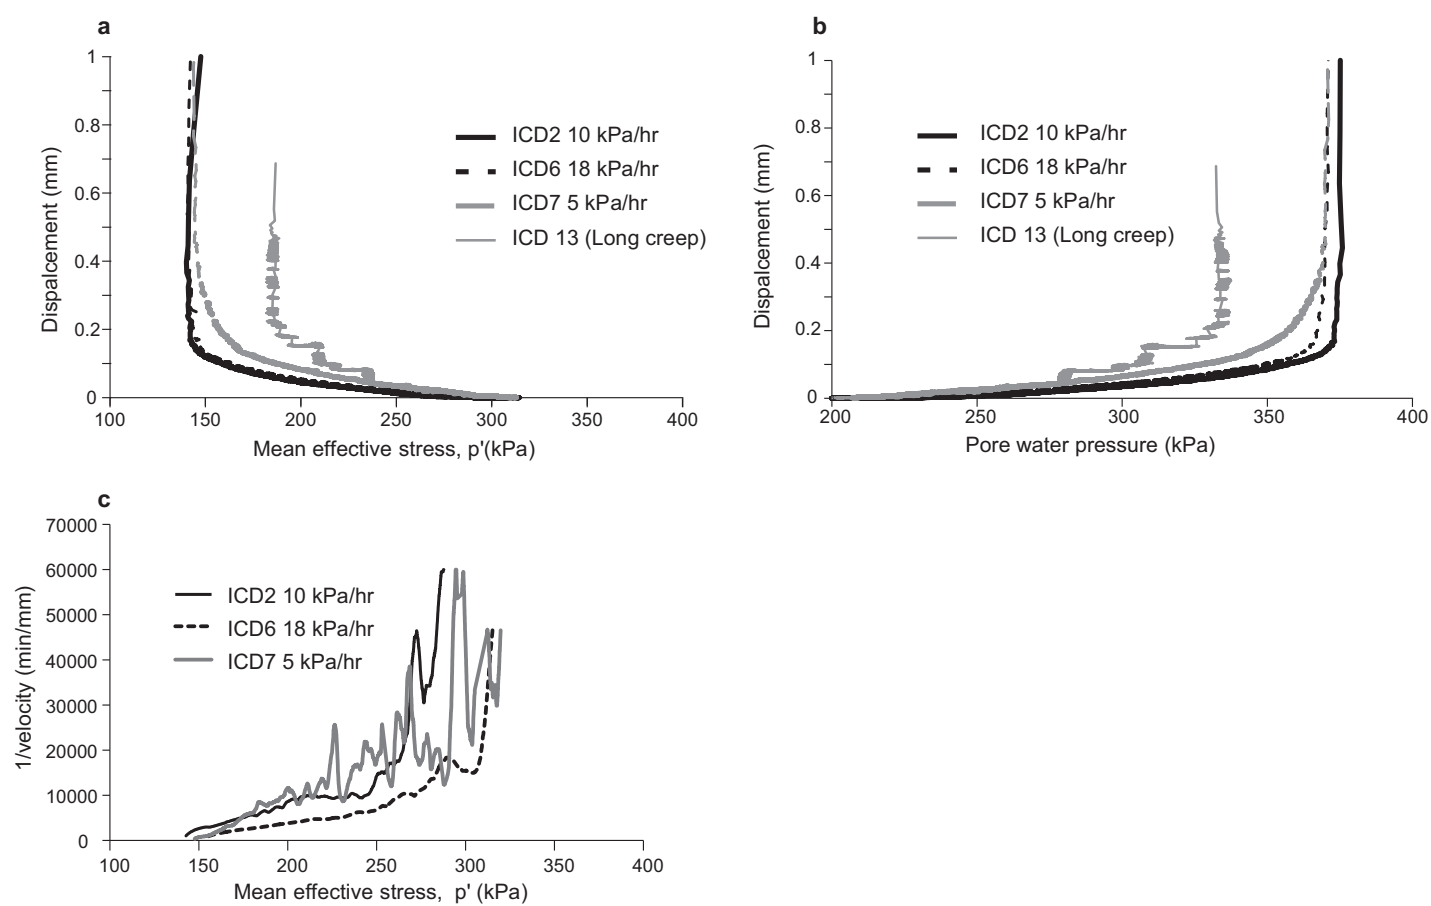
Figure 11

In Figure 11a, the displacement during the PPR phase of the three undisturbed tests, plus the long term creep test, is shown against mean effective stress. The intact Gault Clay shows a progressive brittle failure mechanism as a result of the development of a singular shear surface through the process of strain localisation. For the three PPR tests the behaviour is the same within error. The long term creep test fails at a higher mean effective stress, consistent with the creep rupture results of Singh and Mitchell (1969). The PPR testing indicates that displacement in intact samples of the Gault Clay initiated from a mean effective stress of approximately 300 kPa (Fig 11 a). Final failure appears to occur at a critical displacement rather than a critical stress state.

displacement continues to accelerate exponentially and ductile failure occurs without the development of a singular shear surface. This is illustrated by an asymptotic trend in  $1/v - p'$  space throughout the test (Fig 11 d).

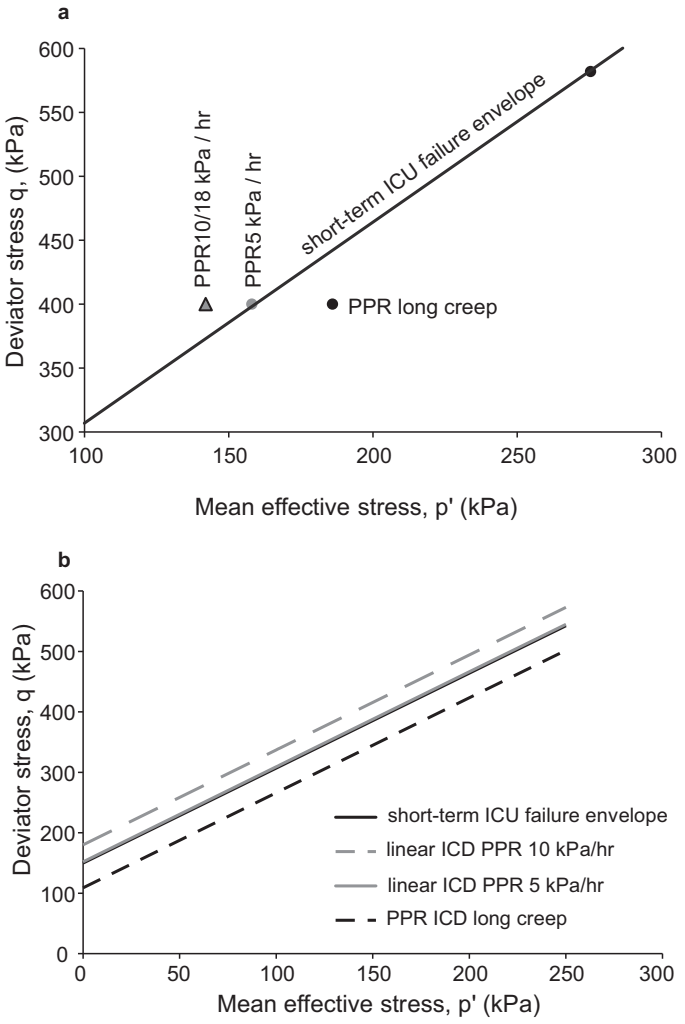
Figure 12

**Figure 12.** (a) Comparison of ICDPPR and PPR long creep failure points in relation to the short-term ICU failure envelope (b) Comparison of ICD PPR and PPR long creep failure envelopes in relation to the short-term ICU failure envelope.

The most important observation is that final failure occurred at a much higher value of mean effective stress than was the case for the linear PPR tests. The 5 kPa / hr test failed at a stress state that is consistent with the ICD failure envelope. The 10 and 18 kPa / hour tests failed at a lower effective stress state, suggesting slightly stronger materials. However, this may also indicate a lack of pore pressure equalisation through the sample (i.e. that the effective stress state in the shear zone was higher than is indicated by the pore pressure measurements at ends of the samples). However, the long term creep test suggests a weaker failure envelope than the ICU tests would imply (Fig 12 b). This cannot be due to a lack of pore pressure equalisation in this case. It is also notable that final failure developed in conditions of constant mean effective stress (Fig. 10); indeed, final failure occurred 81 days after the pore pressures had last been changed. Creep-rupture behaviour is observed in crystalline rocks with deviator stress states below the peak strength. It is a time-dependent process associated with progressive damage accumulation in the sample. The time to failure is inversely correlated with the deviator stress – thus samples in a stress state close to the failure envelope will fail comparatively rapidly; those at lower levels of deviator stress will fail more slowly. Thus, in effect creep-rupture defines a suite of failure envelopes below the ICD envelope. In crystalline rocks these are generally
